Montgomery County Fire and Rescue Service

POST INCIDENT ANALYSIS

**2nd Alarm House Fire
203 2nd Avenue
Washington Grove, MD**

Incident Date: January 14, 2014

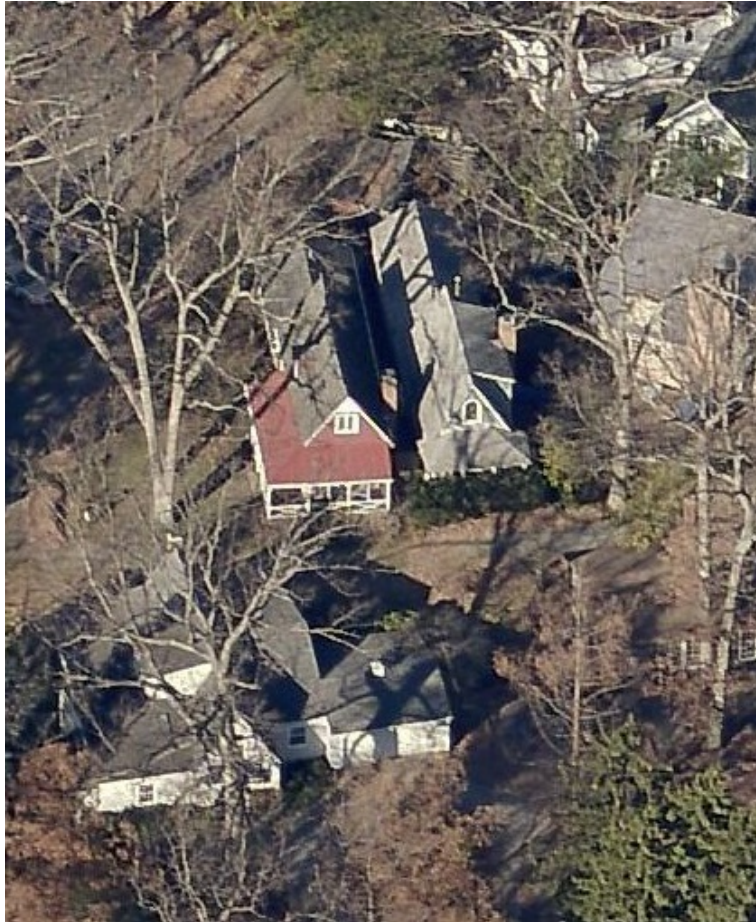
Aerial Image of 2nd Avenue

Paramedic Engine 708 notified Paramedic Engine 728 that they would lay-out from the hydrant in the “The Circle’ & 5th Ave”. Paramedic Engine 708 was unable to access the “The Circle” off of 7th Ave due to poorly identified street signs and limited visibility (no street lights), as well as the fact that 7th Avenue is a narrow unpaved designated walking path. Paramedic Engine 708 again attempted to gain access to “The Circle” via 6th Avenue but had to stop 100 feet short of their designated hydrant due to the fact 6th Avenue was also an unpaved walking path that narrowed considerably. Paramedic Engine 708 instructed Paramedic Engine 728 to pick up their split on the corner of 6th Avenue and Grove Rd and complete the lay to the hydrant at McCauley & 5th Avenue.
